SWITCH UP V2 - ZINC, BLACK POWDER COAT

F-Series Symmetrical Switch Up Swing Handle

Report No#: EN1025L3104R
 Report Date: 2025/01/02
 Test Item: Loading Test,
 Torsional Stress Test (Lock),
 Torsional Stress Test (Screw/Nut),
 Protection Class Test (Waterproof)

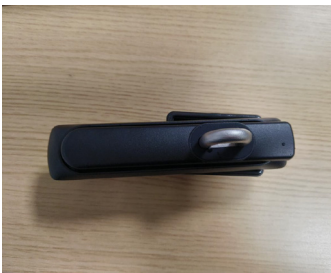
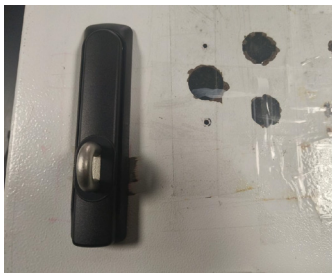
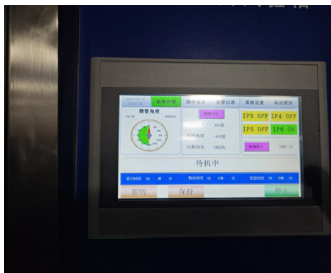
Sample Picture	Installation Status	Control Panel	Water-carrying Capacity

Sample No.	Test Requirement	Conclusion
EN1025L3104-01	No water stains behind door locks, no water stains inside cabinets	OK
