## Test Report

### ESELON+ SERIES | SWITCH UP SWING HANDLES - POLYAMIDE

Sample Name: Swing Handle Lock

Report No#: EN1025A0306R

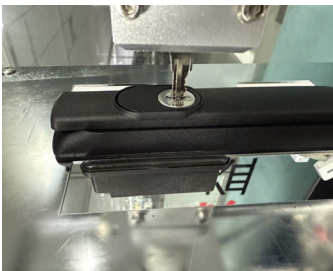
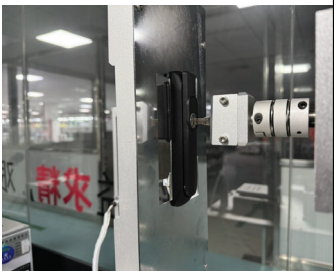
| Sample No. | Test Results | Conclusion |
|---|---|---|
| EN1025A0306-03 | The lock is intact after 5000 locking and unlocking operations. | OK |

The lock is required to undergo 5,000 locking and unlocking operations, means key insertion and extraction and key rotation life tests. After the test, the key and door lock are required to have no obvious damage and not affect the normal use of the product.
